The Chevin Landslides, Otley, West Yorkshire: An explanation of their distribution, morphology and development.

Dr Martin Cross, Leeds Geological Association, November 2024

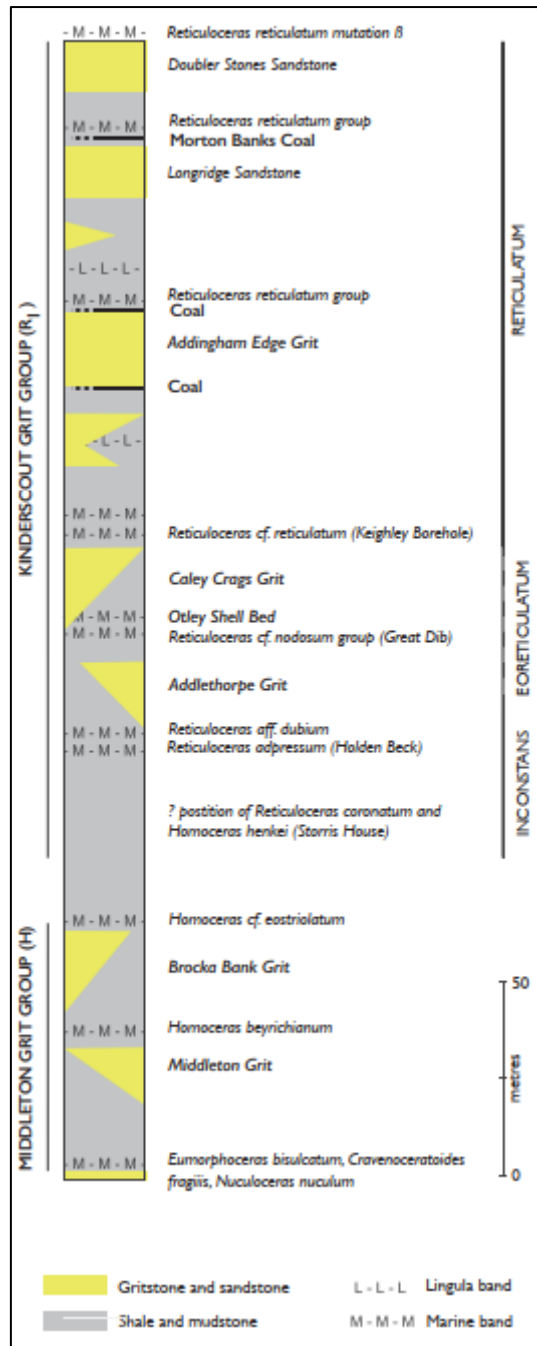
Fig. 2: Generalized geological section of the middle part of the Namurian Millstone Grit succession H and R1 stages.

The Namurian Millstone Grit Group lithologies described in Table 1 are of Marsdenian age; with an approximate age of 318 Ma. This chronostratigraphical sequence was originally established by Edwards *et al.* (1950) and later by Stephens *et al.* (1953). Borehole data, well sections and field correlations have been used to develop a summary of the key geological units in the area (Dean & Lake 1991) (see Fig. 2). To conform to current usage, the Millstone Grit Group has been mapped as a lithostratigraphical unit that includes all strata of Namurian age above the Upper Bowland Shales Formation, which is dominantly argillaceous and therefore, part of the Bowland Shales Group. Important modifications of the Kinderscoutian (R₁) succession have arisen from British Geological Survey boreholes on Rombalds Moor (Aitkenhead & Riley 1996). The exposed Millstone Grit Group Namurian strata comprises approximately 150m of alternating mudstone and sandstone ('rock' or 'grit') beds on the uppermost part of the northern escarpment of the Chevin (see Fig. 3).

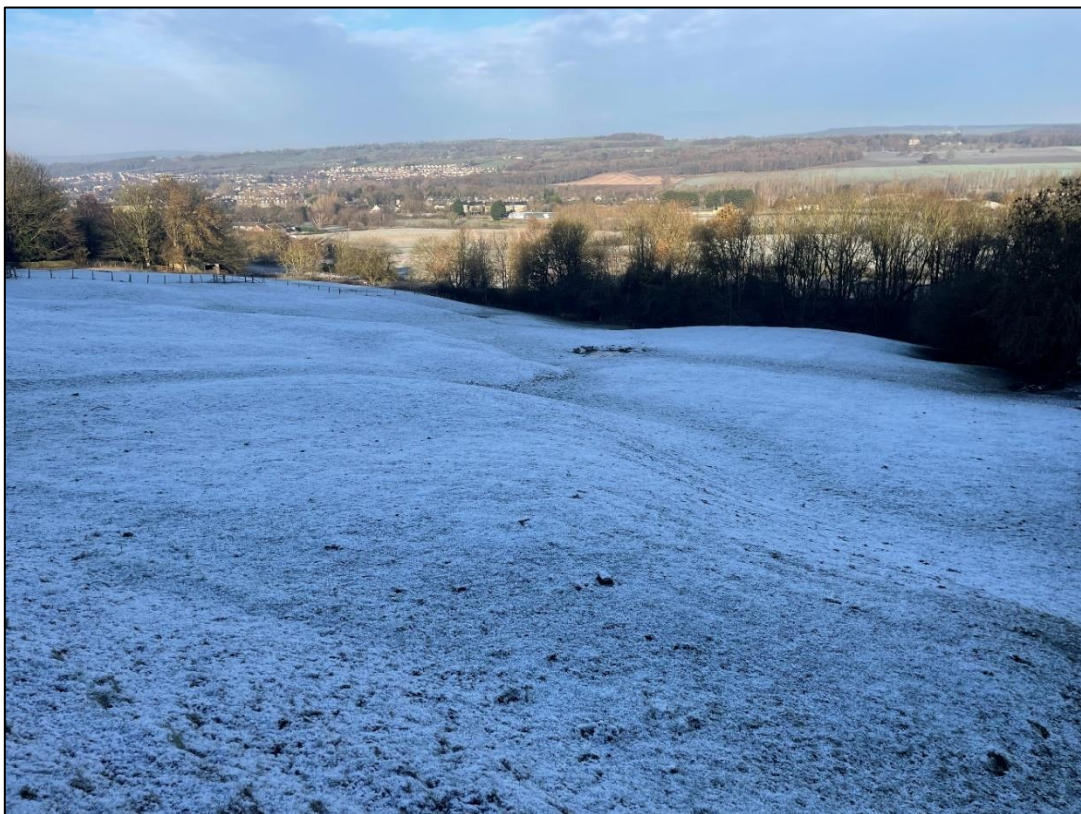
Photo 2: Mudflow toe area (Area 14D).

North and east of The Birches (SE 210 446) extends a complex of deep-seated multiple rotational landslides (Landslides 14A (SE21143 44350) and 14B (SE21143 44762) (see Fig. 6). These landslides have well developed steep back scarps in the Addingham Edge Grit. North of the initial rotated blocks of landslides 14A and 14B, there are secondary rotational failures within an extensive area of mudslides and mudflows extending north of the A660 Leeds Road and Willow Bank 14C (SE 21177 45023). A series of well-developed mudflows can be seen north of the A660 Leeds Road around Willow Bank 14C (SE 21141 45061), Brunswick House 14D (SE 21230 44971) and Arnwood 14E (SE 21402 44954) (see Photo 2).

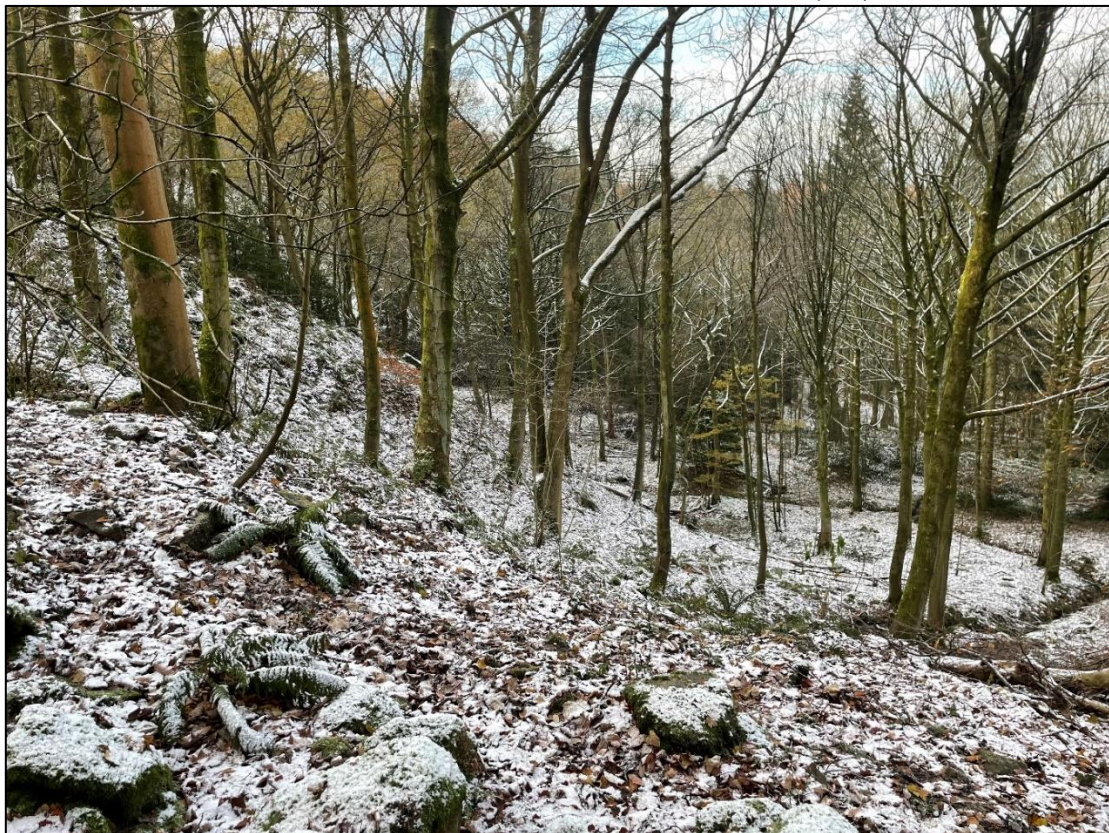
Photo 3. Steep back scarp of rotational landslide (Area 15A).

Danefield Wood (SE 212 445) is an area comprising several large deep-seated multiple rotational landslides (15A). The back scarps of these landslides have affected the Addingham Edge Grit as far south as Springfield Farm 15B (SE 21617 44225), (see Photo 3). Rockfalls have also affected the Addingham Edge Grit. Scattered boulders derived from outcrops of the Addingham Edge Grit are common on the upper slopes and increase in abundance further east. The large deep-seated rotational landslides have had the effect of lowering the crest of the Chevin escarpment along an east west alignment, 150m north of Springfield Farm (SE 21606 44376) in Danefield Wood (15B). The cambering has resulted in the beds of Addingham Edge Grit to tilt gently northwards. Small camber gulls (shallow linear depressions over tension cracks/joints) are present near the crest of the Addingham Edge Grit escarpment, where large blocks have tilted to the north. Several parts of the Addingham Edge Grit have become detached from the edge and have moved downslope. Northwards from this area, massive Addingham Edge Grit blocks litter the slope and mudslides and mudflows supporting the detached gritstone blocks are widespread over the lower slopes south of the A660. The debris aprons of the rotational landslides are marked by hummocky ground extending to the north and west. The northern extent of the hummocky ground of the main rotational landslides (15A) is marked by a line of springs (SE 21508 44687). Well-developed mudslides and mudflows (SE 21546 44922) extend northwards from the main accumulation areas of the rotational landslides (15C).

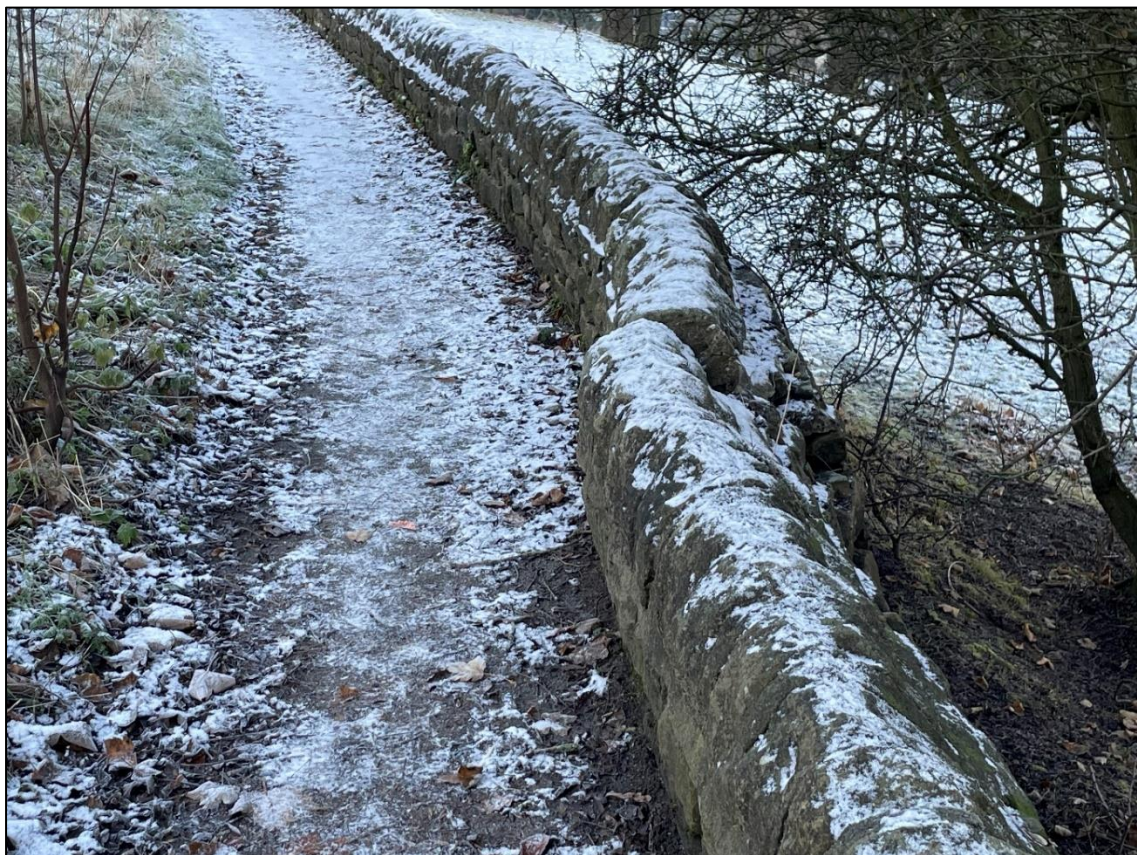
Photo 4. Damaged retaining wall north of A660 (Area 16C).

Several small to medium-sized rotational landslides south of Water Trough Bend 16A (SE 21896 44515) have resulted in significant damage to the A660 over many decades. Numerous springs are located at the northern edge of the rotational landslides and widespread mudslides and mudflows (SE 21818 45074) have spread downslope northwards. A small rotational landslide scarp slope is located south of the A660 at Water Trough Bend (16A). The active area of landsliding at sub area (16B) has caused movement of the retaining wall constructed on the north side of the A660 (see Photo 4).

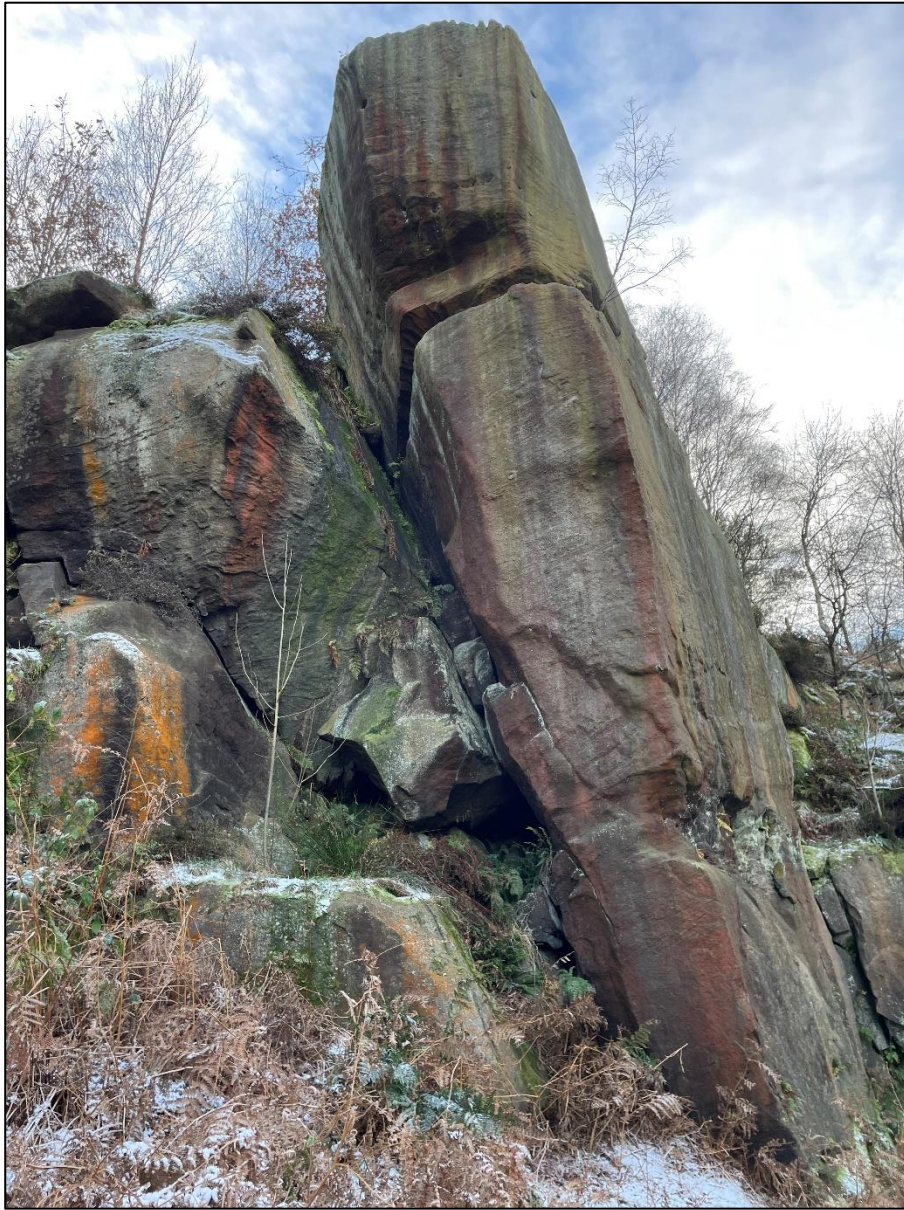
Photo 5. Gritstone Edge comprising Addingham Edge Grit showing large open joint behind the face (Area 18B).

South of the A660 at Pools Carr (SE 22592 44405), the valley side comprises of a series of large deep-seated rotational landslides which extend from the Addingham Edge Grit escarpment (18A) (see Photo 4). The back scarp (5m in height) of one of the landslides 80m south of the A660 has resulted in a large block failure in the Addingham Edge Grit (18B) (see Photo 5). Below the back scarp of the rotational landslide are a series of slumps, each with a throw of several metres, each of these is separated by a small back scarp. The back scarps have associated marshy areas. North of the A660 are numerous mudslides and mudflows and abundant springs. West of Pools Carr is an active landslide and mudflow 18C (SE 22493 44777). Northwards movement of this active area has displaced the northern retaining wall of the A660 by approximately 1m over a length of 120m; the wall has also subsided by 0.3m. Several springs emerge beneath the retaining wall on the north side of the A660. The presence of several small back scarps and associated mudflow features indicate that the landslide is a complex of rotational landslides with associated mudflows. South of the A660 the slope is hummocky and littered with many large, detached gritstone blocks 18D (SE 22581 44602).

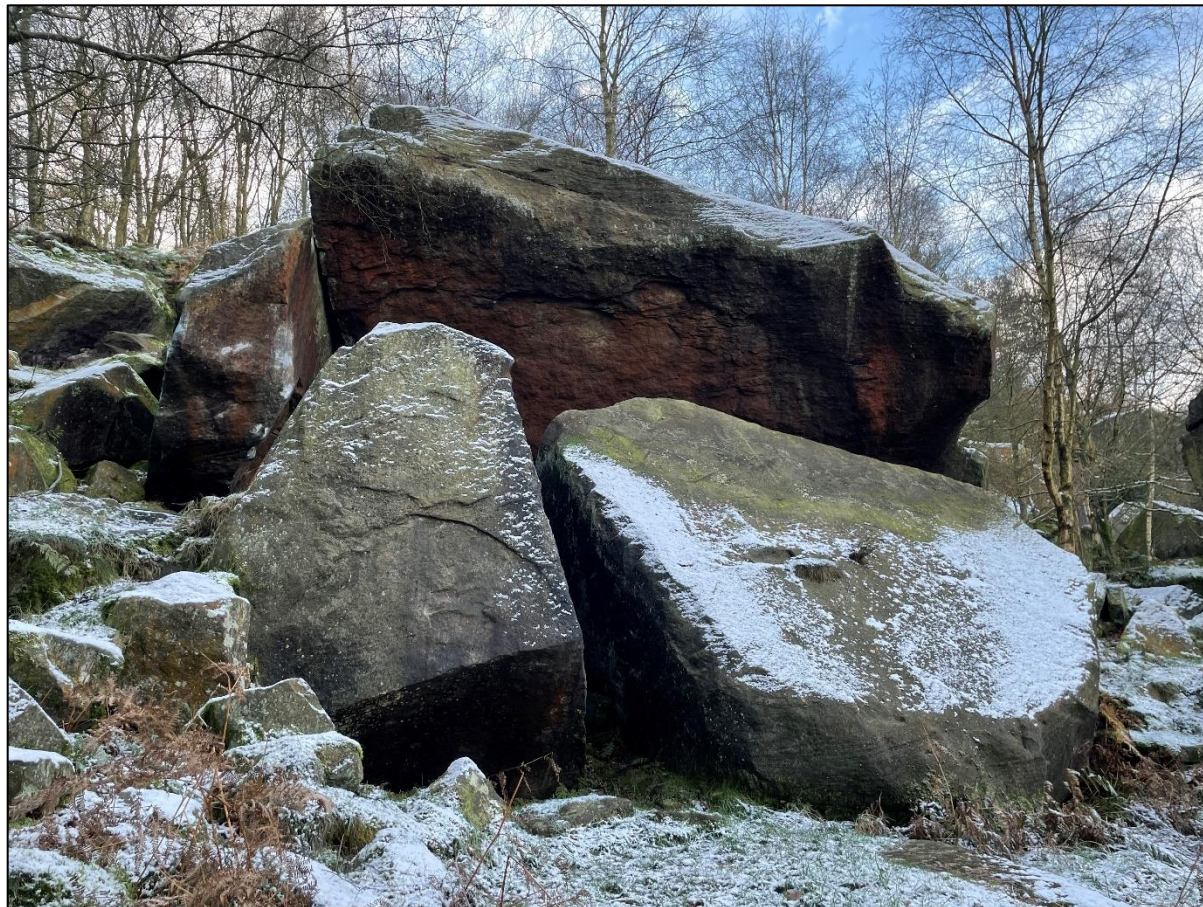
Photo 6. Rafted boulders which have become detached from gritstone edge comprising Addingham Edge Grit (Area 19B).

To the north of Caley Crags, the Chevin escarpment falls away steeply; this area coincides with the back scarps of several large rotational landslides 19A (SE 22876 44293). The Addingham Edge Grit escarpment is cambered 19B (SE 22739 44360) and several large gritstone blocks have become detached and moved down slope onto the rotational landslide accumulation zone (see Photo 6). Numerous springs emerge near the
